IMPLEMENTATION OF PRECISION IRRIGATION TECHNIQUES IN TURF PRODUCTION

FARM 1 CASE STUDY

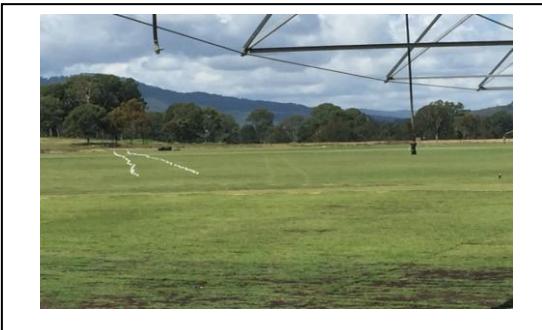
Picture 1: Catch Can Test

Irrigation consultants were engaged to assess the uniformity of water application of the centre pivot. The first assessment was undertaken in August 2014 at planting and it showed that the coefficient of uniformity was just 72.5%.

- Repair/replace the sprinkler pack
- Consideration be given to using rotator or wobbler type sprinklers that are better suited for turf applications
- Change the pressure regulators
- Repair the end gun

Centre pivot: The coefficient of uniformity for the system was measured at 79.4%, which was well below its potential, but an improvement on the initial evaluation. There were sprinklers not performing effectively and some were not to specification. The end gun performed better as a result of changes to pumping capacities and pressures.

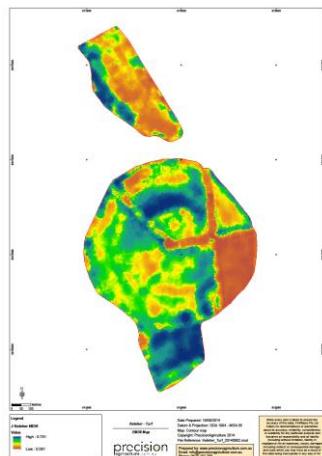
Figure 3: A crop map (NDVI) generated from readings from a Greenseeker. Blue and green readings indicate greater biomass/plant health.

Crop vigour: Crop mapping was conducted (see Figure 3) using Normalised Difference Vegetation Index values derived from the reflectance of bands of light hitting the crop. The measurements can be used as indicators of plant biomass and health, and identify areas requiring watering or fertiliser treatments.

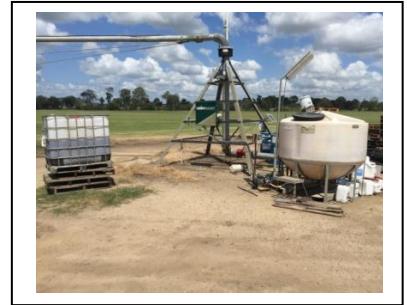
Picture 3: Fertiaator

Fertiliser and nutrient regime: A mechanical agitator with dual impeller was purchased to enable granular and soluble fertiliser to be applied through the centre pivot irrigator. Fertigation commenced on 10 November 2014
