ADOPTION OF PRECISION IRRIGATION TECHNIQUES IN TURF PRODUCTION

FARM 2 CASE STUDY

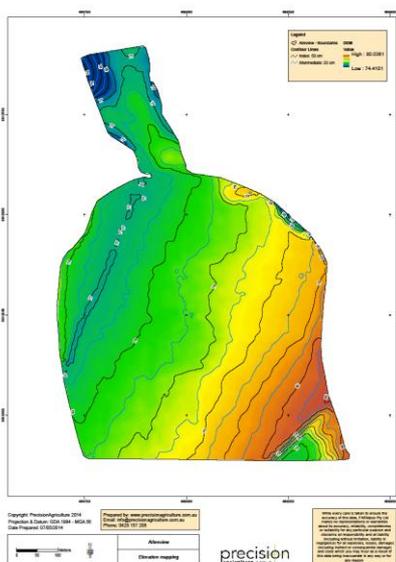
Figure 1: A contour map of the farm.

An ElectroMagnetic(EM38) survey was undertaken to determine soil attributes, so that the cropping area could be zoned for likely differences in soil conditions (see Figure 2 and Figure 1 contour map). EM38 measures apparent electrical conductivity in the soil profile. It will differentiate soils having higher clay content, higher moisture levels or higher levels of dissolved salt, either alone or in combination. Significant variation in EM38 measurements were observed under the pivot irrigator. These were later verified by a number of soil tests.

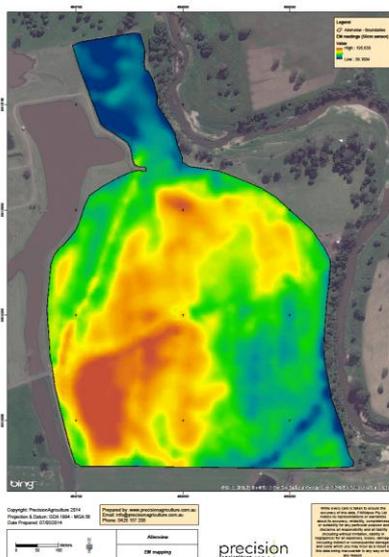
Figure 2: Soil map (shallow), generated from readings from an EM38 (50cm coil). Red/orange readings can indicate soils with more soil moisture or clay.

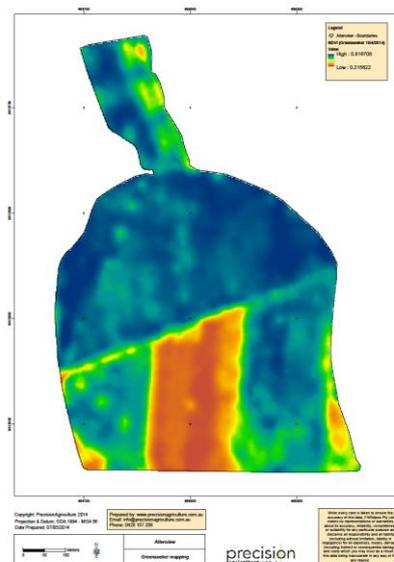
Figure 3: A crop map (NDVI) generated from readings from a Greenseeker. Blue and green readings indicate greater biomass/plant health. Orange indicates recently harvested areas.

Crop vigour: Crop mapping was conducted using Normalised Difference Vegetation Index (NDVI) values derived from the reflectance of bands of light hitting the crop. The measurements can be used as indicators of plant biomass and health and to identify areas requiring watering or fertiliser treatments. The NDVI values from April 2014 indicated that the turfgrass was relatively uniform. The grower had manually compensated for the strong underlying variance revealed by the soil map with judicious fertilising using a boom sprayer. Rates of fertiliser application were increased in areas of nutrient deficiency by slowing tractor speed to give a uniform crop.
